DELL® 3100 CN CARTRIDGE REMANUFACTURING INSTRUCTIONS

INCLUDES CHIP REPLACEMENT PROCEDURE

DELL® 3100 CN TONER CARTRIDGE

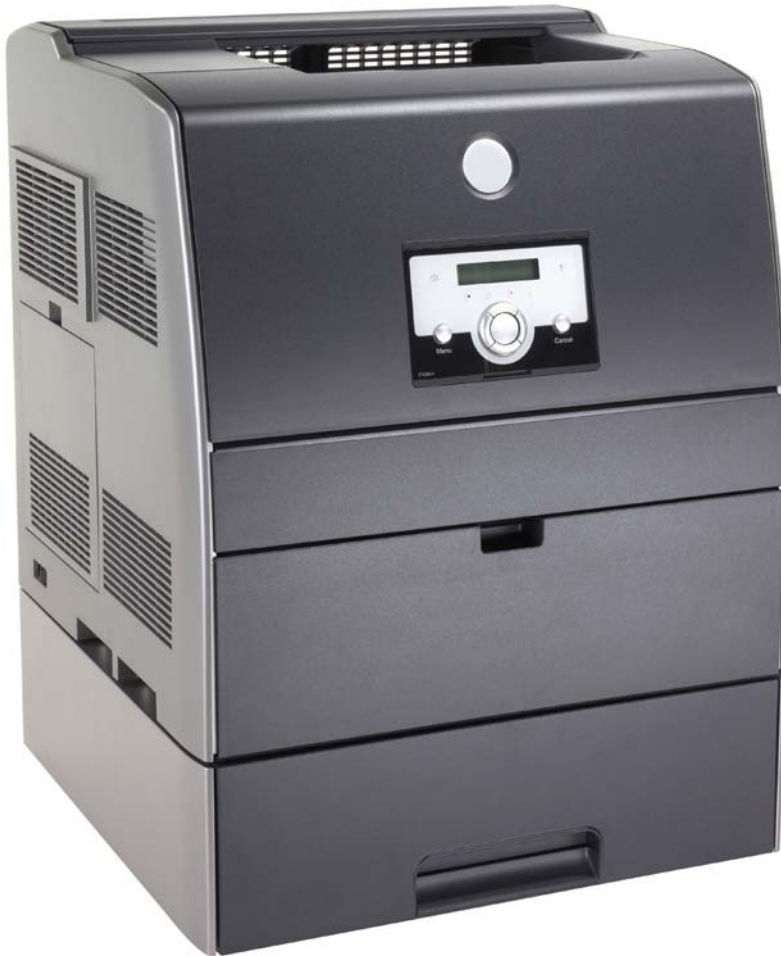
DELL® 3100 CN
COLOR LASER PRINTER

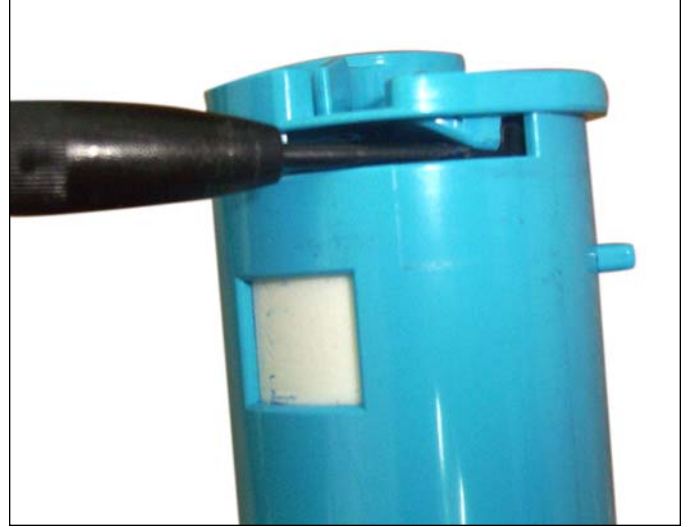
2. Use a small flat-head screwdriver to lift the tap over the stopper and allow you to turn the blue end piece counter-clockwise (color of end piece varies on color of cartridge).

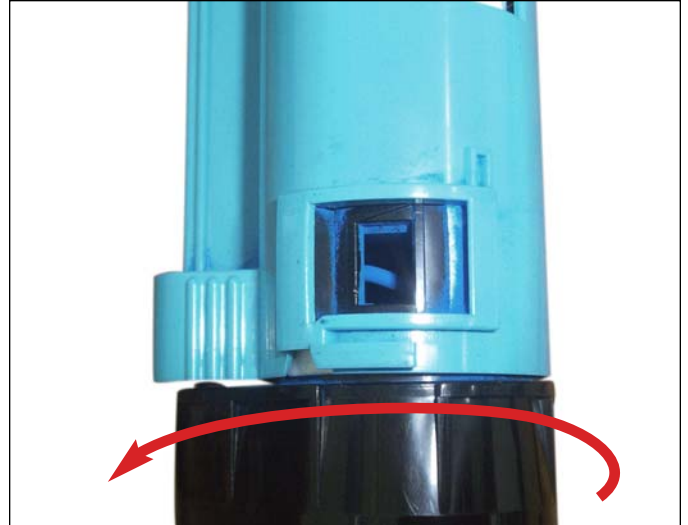
4. Turn the cap until the tab comes to a complete stop and has entered under the blue cap.

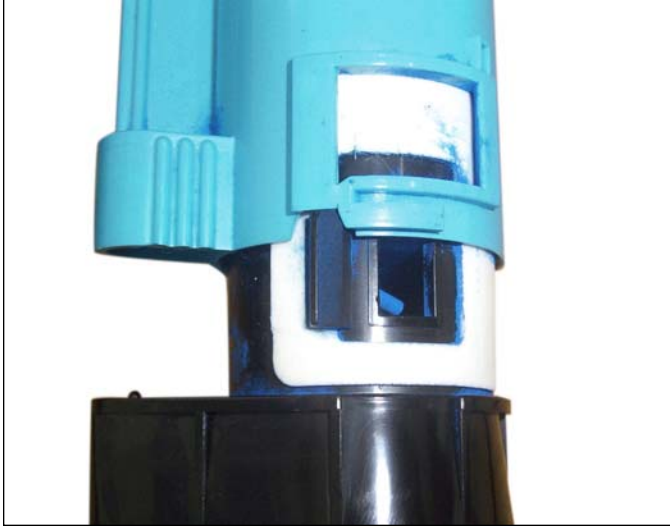
5. Now pull the cap, out away from the cartridge.

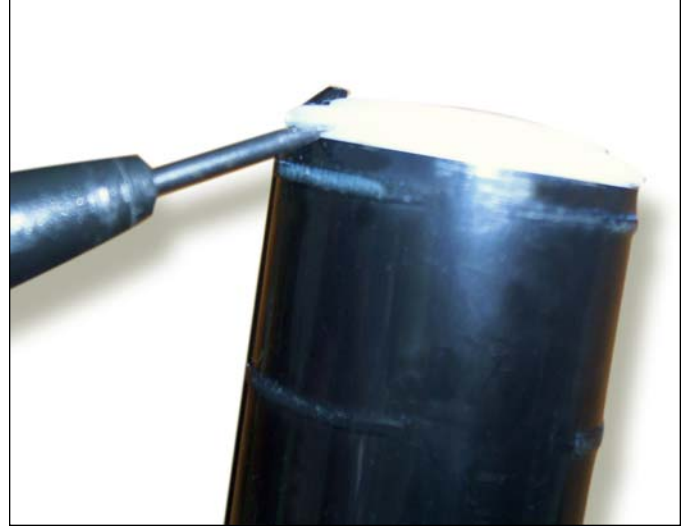
6. Remove the carrier fill plug.

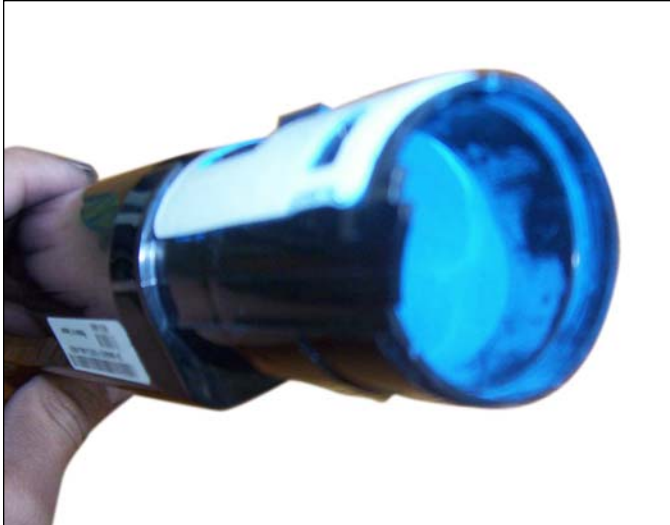
7. This is the waste carrier chamber, empty it out and you will find the toner fill plug. Remove it to clean cartridge and fill toner.

NOTE: Mix toner and carrier in the same toner bottle before refilling the toner hopper.

Problem	Cartridge is not being read or recognized by the printer.
Details	The machine reads the amount waste carrier-toner located on the waste hopper bin, if the waste hopper bin compartment is full, the machine might read that the toner cartridge is empty and thus, showing a “toner low” message. After refilling, follow these simple steps to continue printing.
Suggestion	<ol style="list-style-type: none">1. Turn OFF the printer for 3 to 5 minutes, and turn it ON again.2. Once the printer is ON, remove the cartridge from the printer, shake and install it again.3. If steps 1 and 2 did not work, remove the cartridge and empty any carrier-toner left on the waste hopper bin.

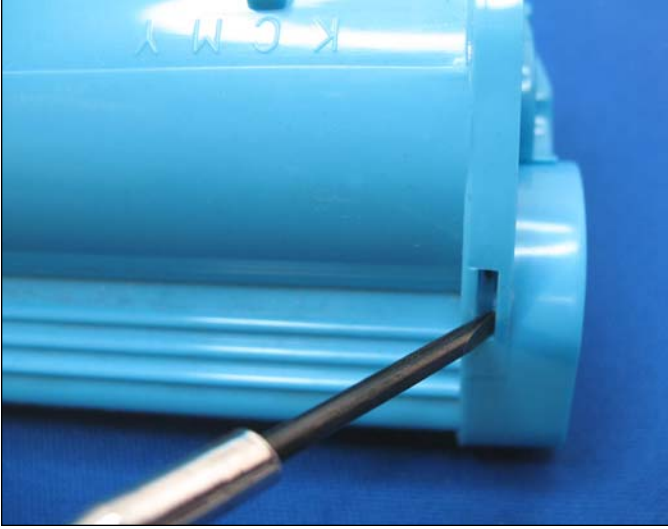
REPLACING THE OEM CHIP

8. Using a small flathead screwdriver, unlock the chip by pressing the release tab in the slot shown.

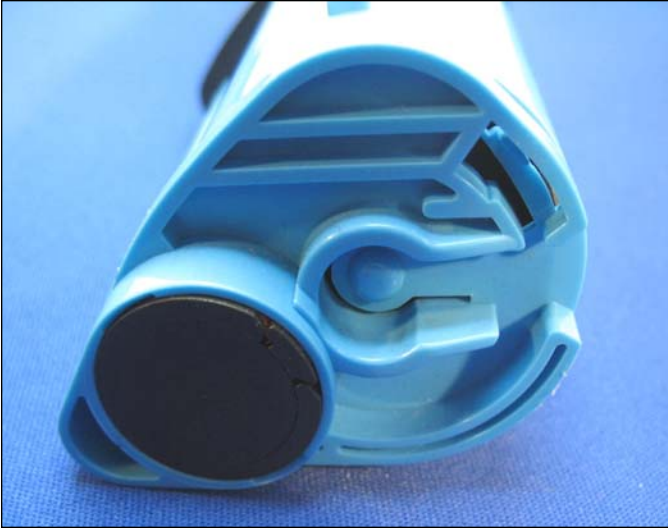
3. Replacement chip installed.
