LEXMARK™ C520 • 522 • 524 • 530 • 532 • 534 CARTRIDGE REMANUFACTURING INSTRUCTIONS

**LEXMARK™ C522
COLOR LASER PRINTER**

TONER CARTRIDGE

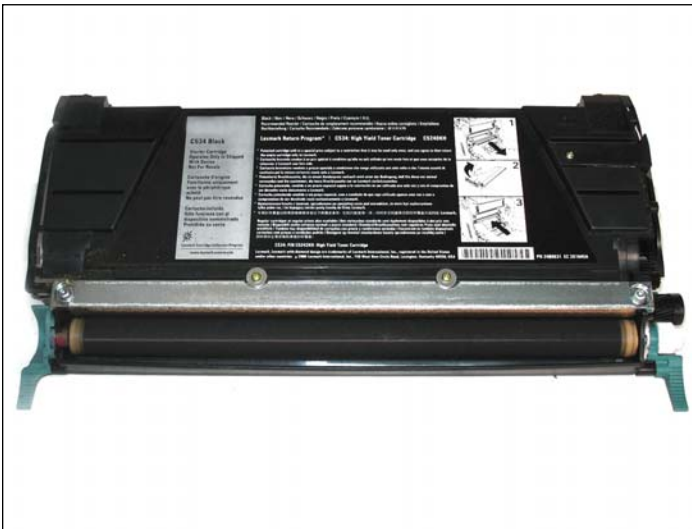
TONER CARTRIDGE FRONT VIEW

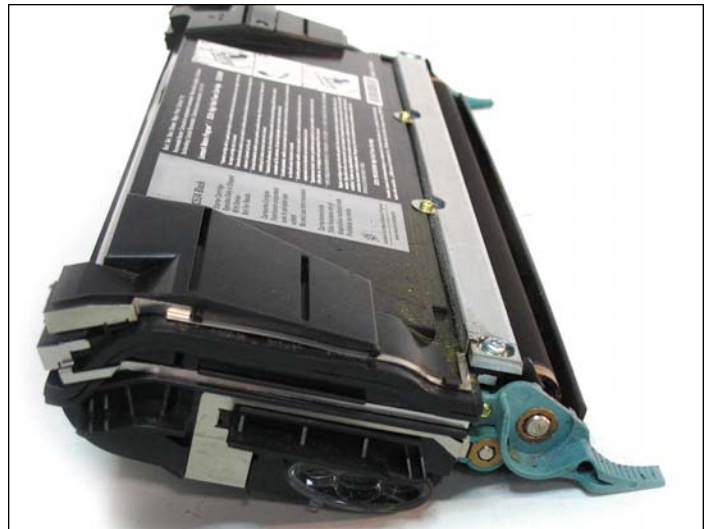
CARTRIDGE CONTACT SIDE

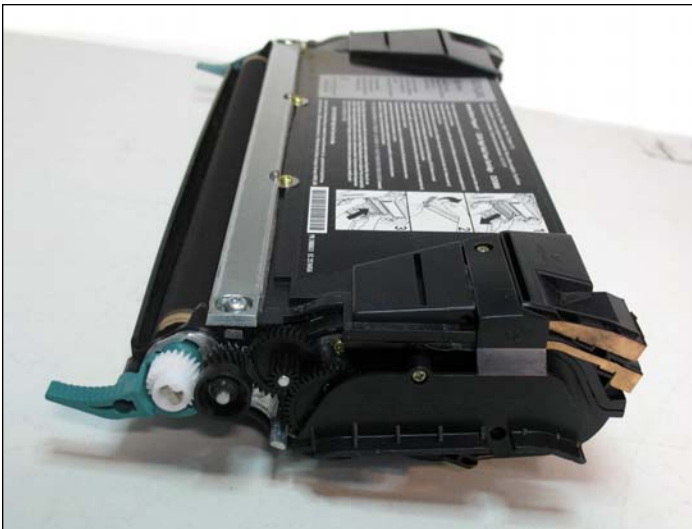
CARTRIDGE GEAR SIDE

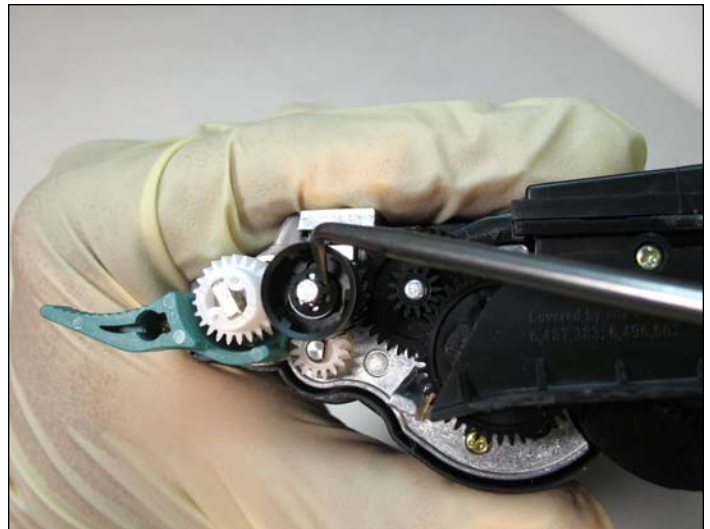
REMOVING THE GEAR TRAIN
1. Remove locking ring.

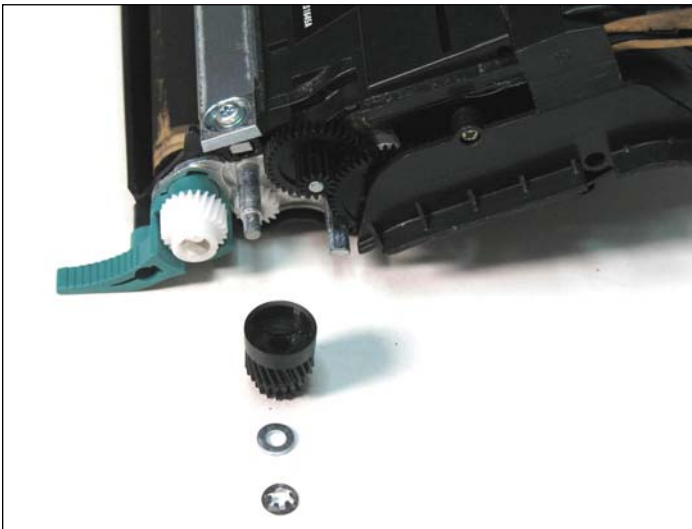
2. Drive gear removed.

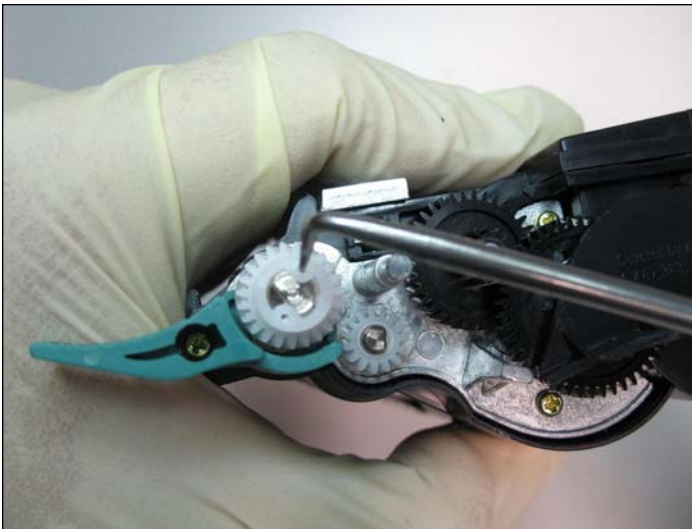
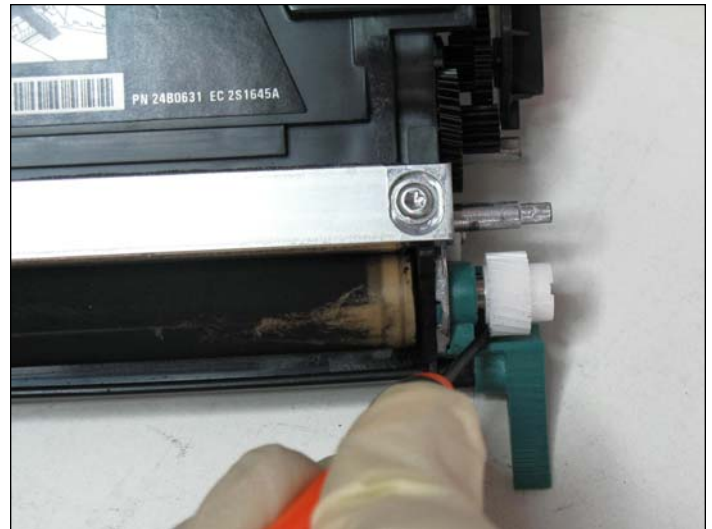
3. To remove the DVR roller gear, first rotate the gear clock wise until it stops. Then, using a small flat head screw driver, pry the gear off of the DVR roller axle against the DVR roller support. Note: the gear has a minimal amount of pressure so there is no risk of using this technique.

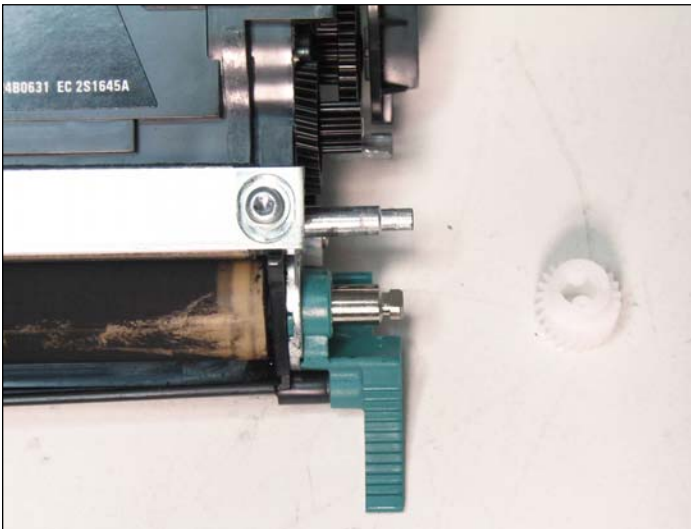
4. Drive gear removed.

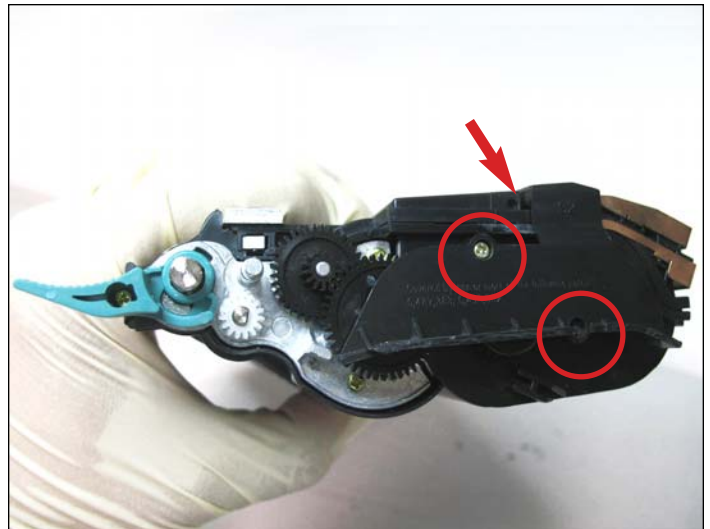
5. Continue by removing the smartchip holder. There are three screws holding it to the hopper (marked where indicated).

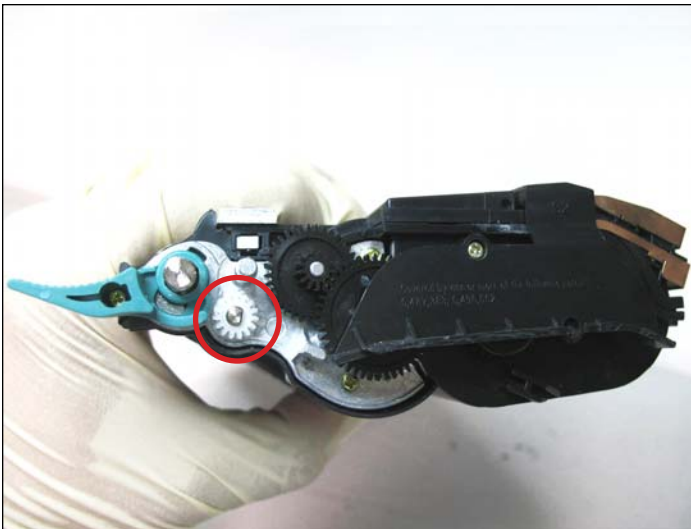
NOTE: Please use extreme caution when removing the supply roller gear (circled) as it is very fragile and might break if removed forcefully.

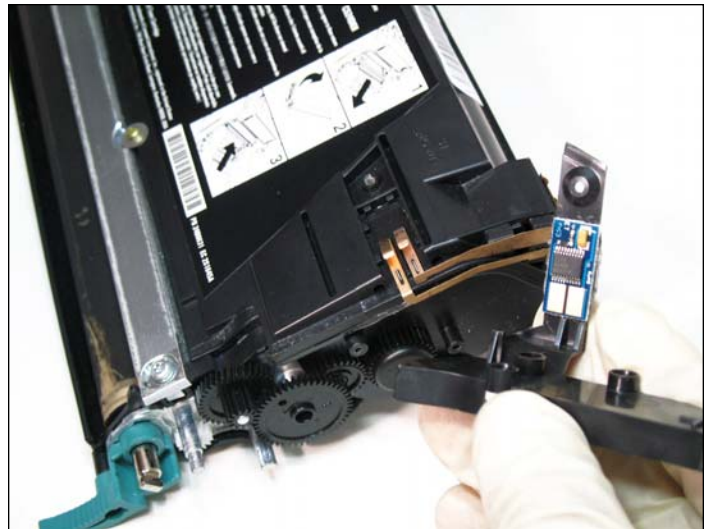
6. Chip holder removed.

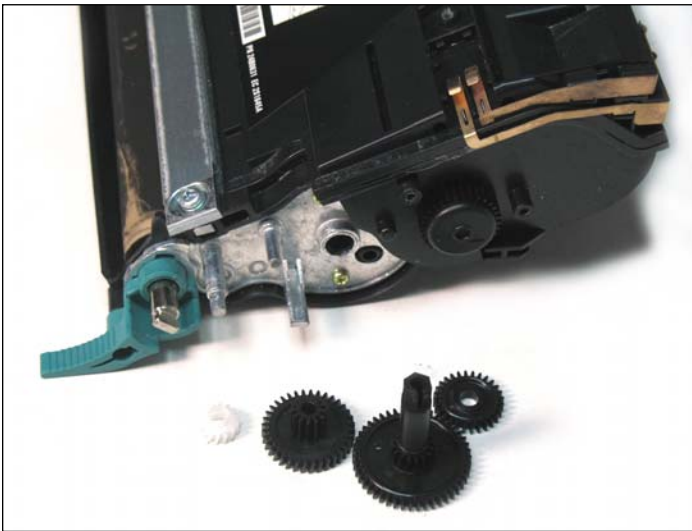
7. Drive train removed.

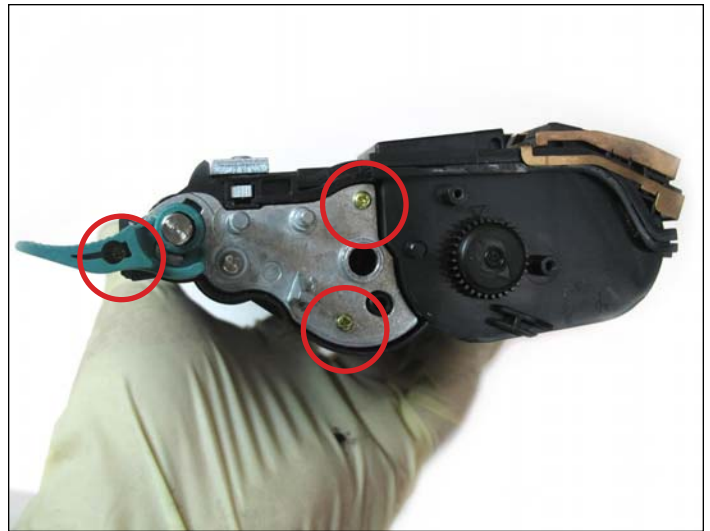
8. Remove the three screws holding the DVR roller support plate (marked with circles).

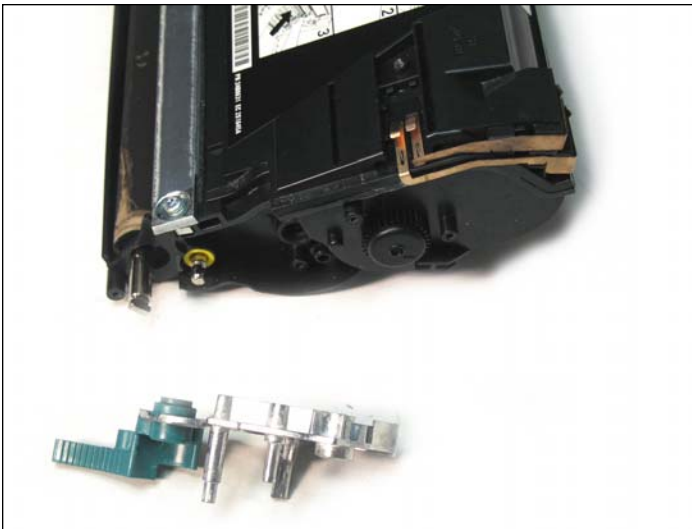
9. Support plate removed.

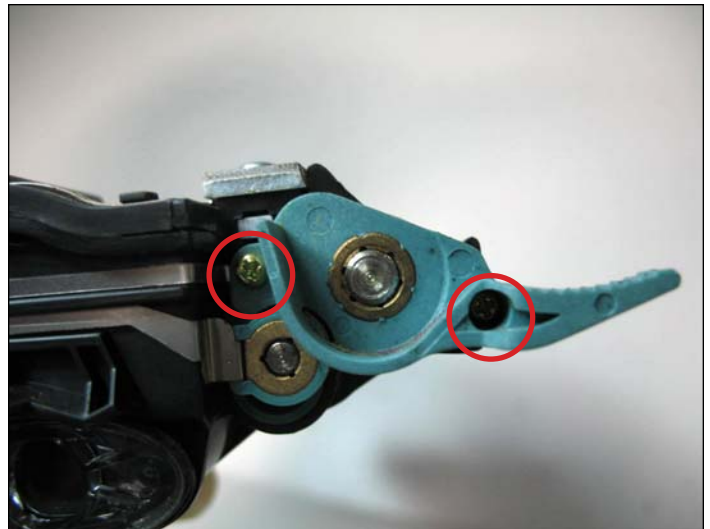
10. Remove the small DVR support plate on the contact side by removing the two screws holding it in place (marked with circles).

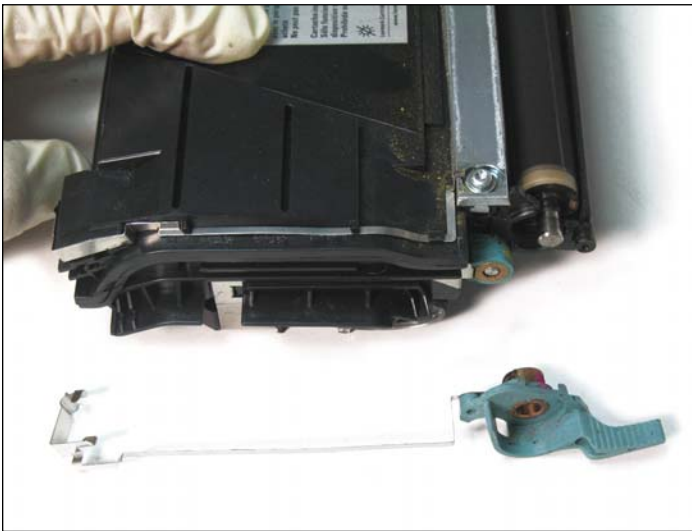
11. Once the DVR support plate has been released, removed with the rear contact as shown.

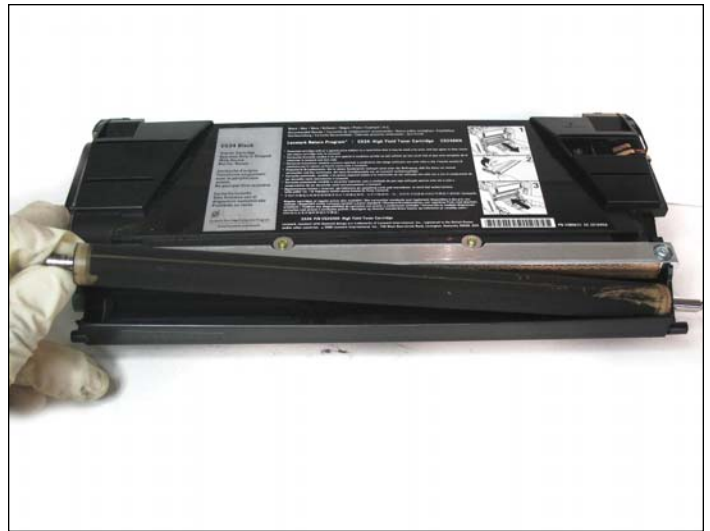
12. Remove the DVR roller.

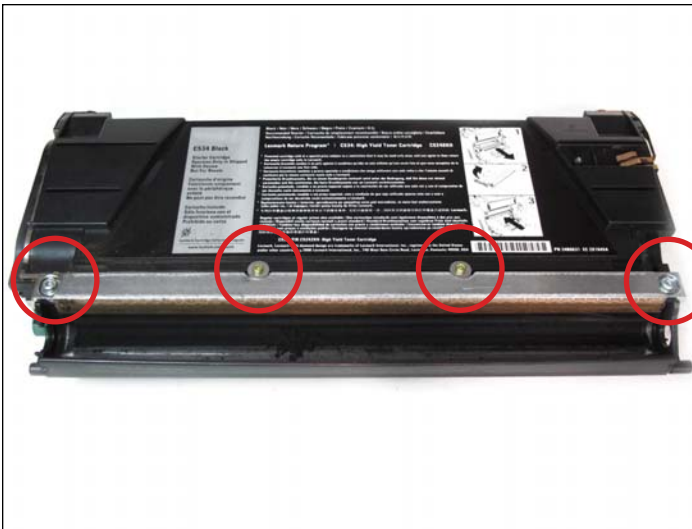
13. Remove the doctor blade by removing the four screws as shown. Note: the location of the doctor bar. It needs to be positioned in the same manner as before.

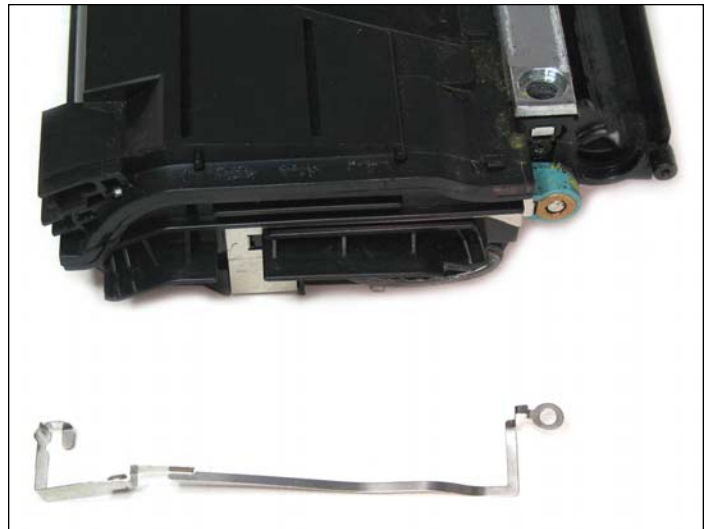
14. Remove the doctor blade contact which runs along the side of the cartridge.

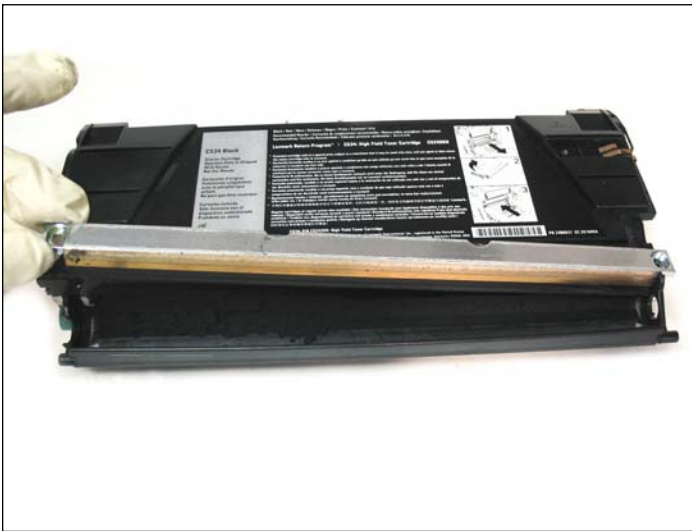
15. Remove the doctor blade as shown.

Clean hopper thoroughly using compressed air and refill through opening shown with appropriate amount of toner.

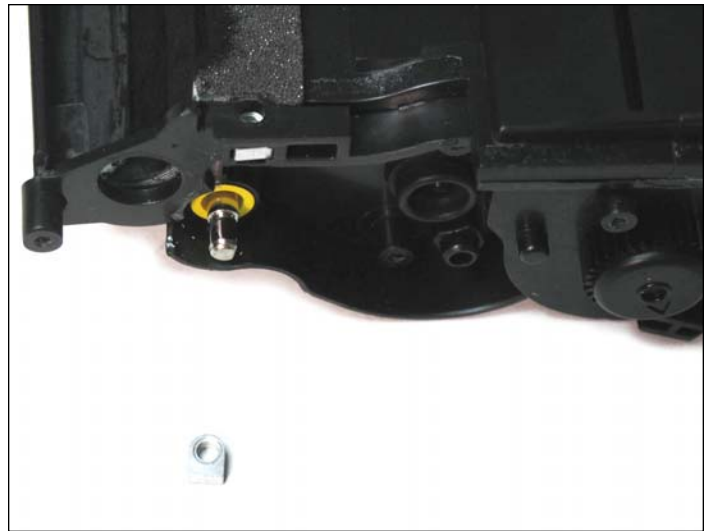
NOTE: Be careful not to lose the doctor bar nuts, since the screw has been removed the nuts are not fastened and can easily be lost with any movement of the cartridge.

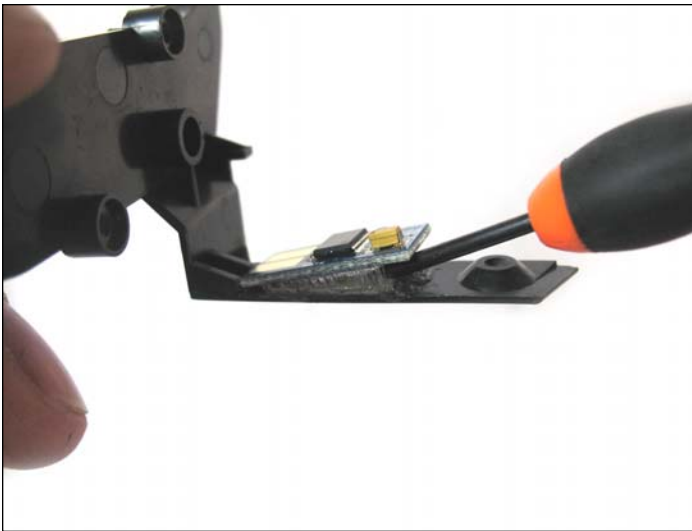
16. Remove the chip which is held on by an adhesive backing.

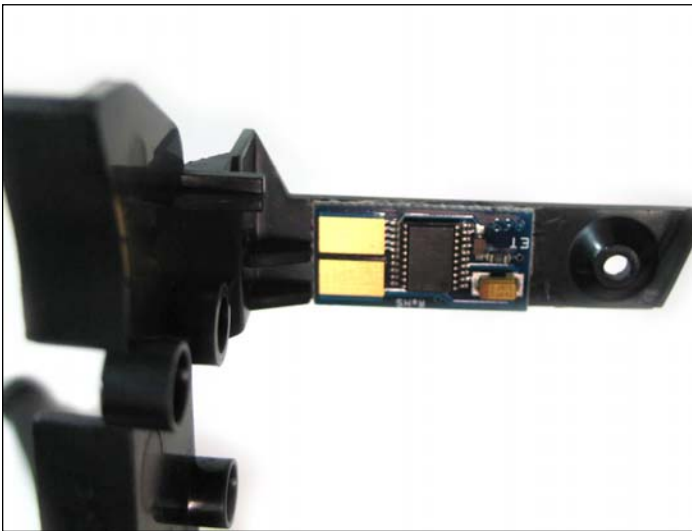
17. Install the chip with the contact facing inward, as close to the tab as possible.

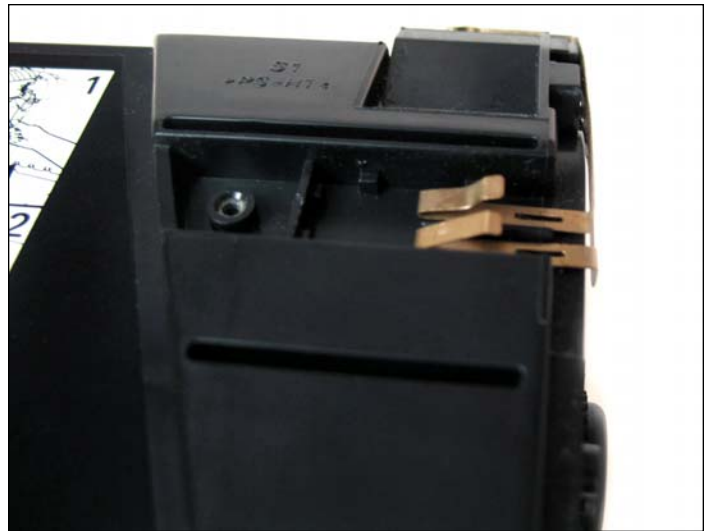
NOTE: Since the aftermarket chips have a larger micro processor than the OEM we recommend adjusting the chip contacts to create an S shape design to avoid any interference with the processor.

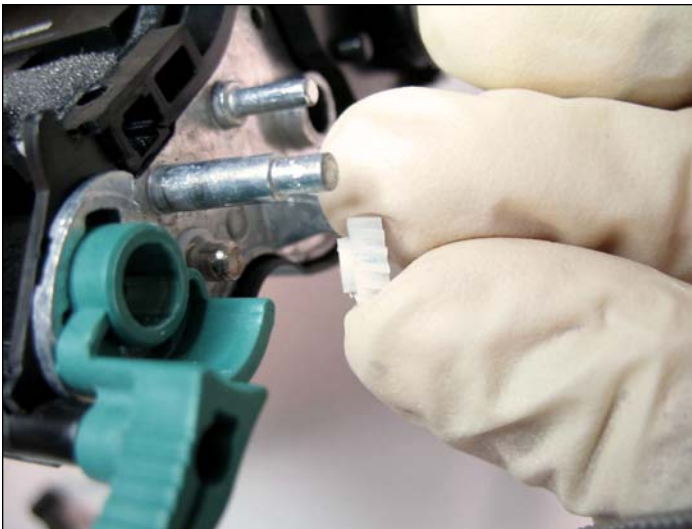
18. **TECH TIP:** Carefully reinstall the supply roller gear in the position shown.

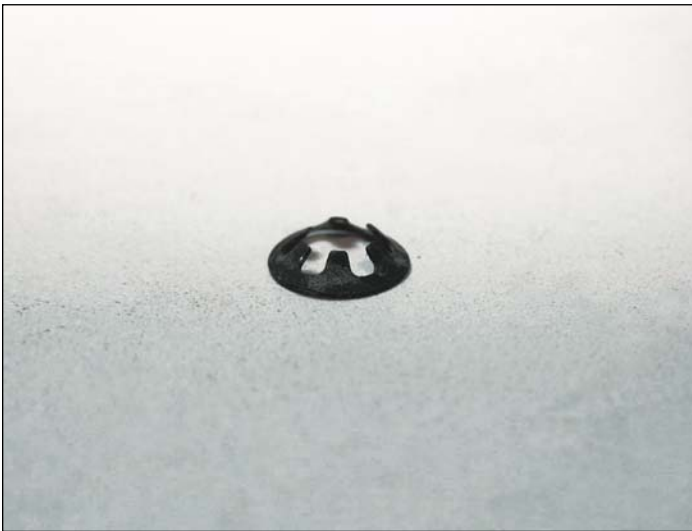
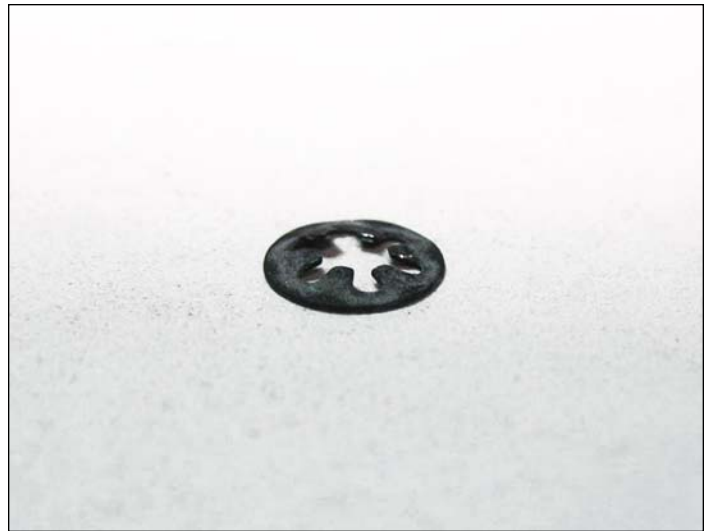
19. **TECH TIP:** Adjust the drive gear locking ring to prevent the drive gear from slipping off.

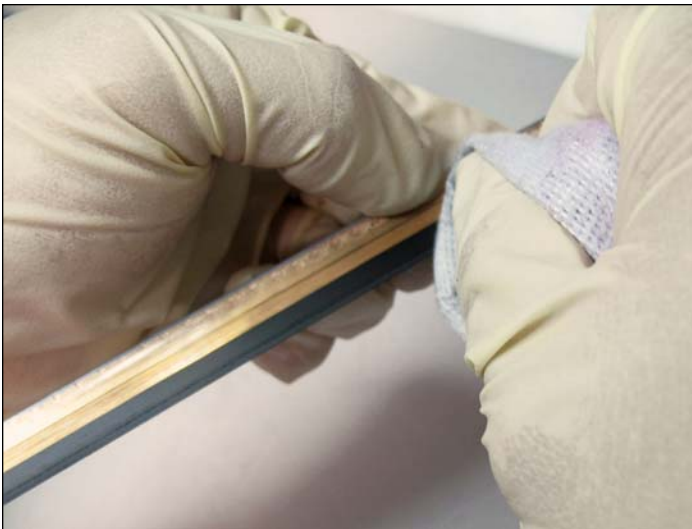
20. **TECH TIP:** Wipe off any access toner from the doctor blade, if crusting is present you can use Isopropyl Alcohol to remove the residue. Avoid scratching the coating on the doctor blade with your nail or other sharp objects.

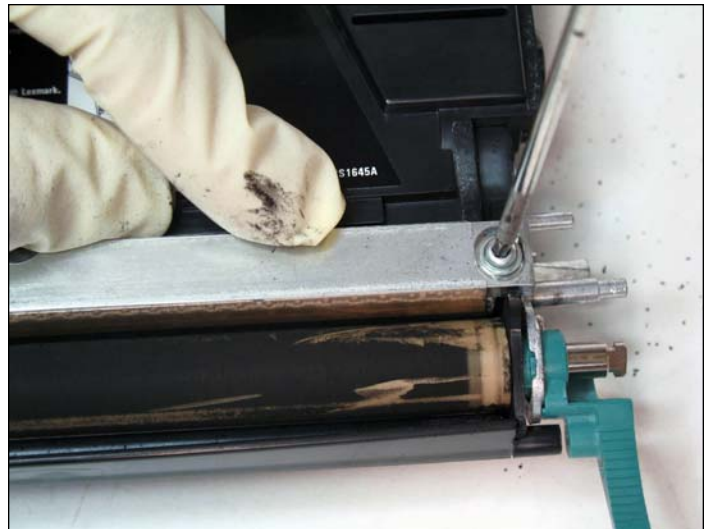
21. **TECH TIP:** Install the doctor blade in the right position by applying some pressure, press it towards the DVR and fasten the end screws.
